**Flood Control Project Maintenance
Levee Inspections**
LMA District Cover Sheet
Spring 2018 Levee Inspection Results

Sutter Maintenance Yard Tisdale Bypass

Levee Inspection Report By Mile - Spring 2018

Waterway	Bank	Unit Miles	Inspection Start/End	Inspector
Unit No. 01 Tisdale Bypass	Left	4.51	03/27/2018 03/27/2018	Bob Duffey

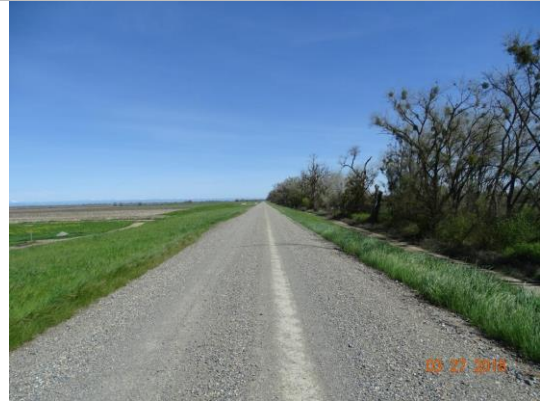
Photo 1 of 1 : SP_2018_ST0009_286_10_20180403_00020.jpg

LM Start	1.08	Rating **	A	Issue No.	10
LM End	1.08	Issue Type +	Ma	Location *	LS
Category	Earthen Levee			GPS Latitude/Longitude	
				Start	End
Item	Vegetation			39.028307 °	39.028307 °
				-121.801960 °	-121.801960 °
DWR ID	DWR_ST0009_01_s_2018_10				
Comment Code					
V1 : Control annual grass and weeds on the levee slopes and easements.					
Inspector Comment					
Lma should continue to manage the native grasses on both slopes.

View of native grasses on both slopes.

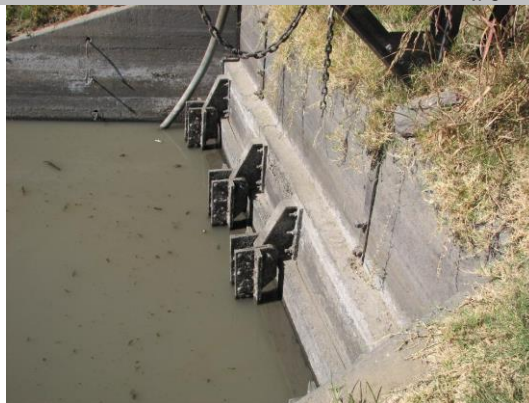
Photo 2 of 3 : UCIP_SP_2018_51484_64225.jpg

Wooden Flap gates on WS toe.

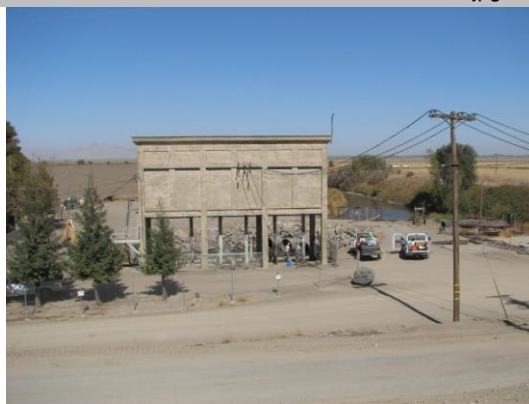
Photo 3 of 3 : UCIP_SP_2018_51484_64224.jpg

Pump house on LS toe.

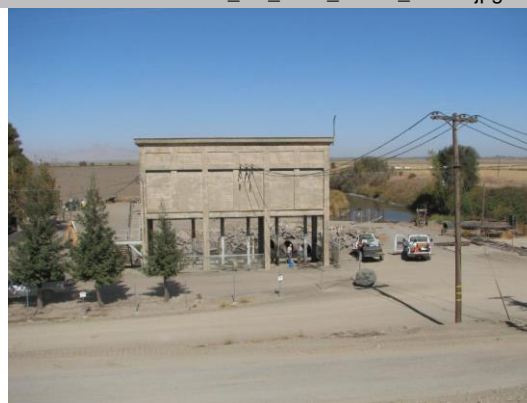
Photo 3 of 3 : UCIP_SP_2018_51485_64228.jpg

Pump house on LS toe.

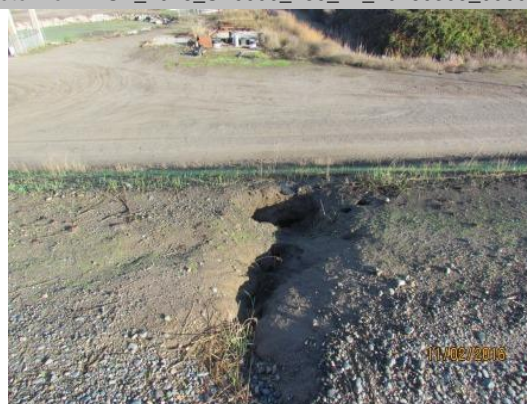
Photo 1 of 2 : SP_2018_ST0009_286_12_20180305_00003.jpg

LM Start	2.16	Rating **	U	Issue No.	12
LM End	2.16	Issue Type +	Ma	Location *	LS
Category	Earthen Levee			GPS Latitude/Longitude	
				Start	End
Item	Animal Control			39.028137 °	39.028137 °
				-121.782020 °	-121.782020 °
DWR ID	DWR_ST0009_01_f_2016_12				
Comment Code					
A3 : No rodents visible, but rodent burrows visible; need to backfill and compact or grout burrows.					
Inspector Comment

View of a rodent hole along the levee crown.

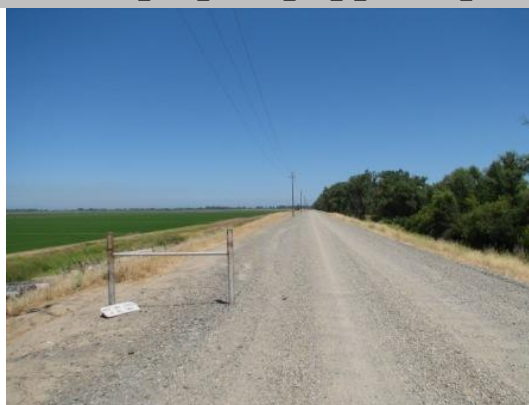
Photo 1 of 1 : SP_2018_ST0009_286_3_20180305_00001.jpg

LM Start	2.19	Rating **	M	Issue No.	3
LM End	4.11	Issue Type +	En	Location *	LS
Category	Earthen Levee			GPS Latitude/Longitude	
				Start	End
Item	Encroachments			39.028173 °	39.028012 °
				-121.781475 °	-121.745665 °
DWR ID	DWR_ST0009_01_s_2012_3				
Comment Code					
PO : Pole					
Inspector Comment

View of the PG&E poles along the landside crown of the levee.

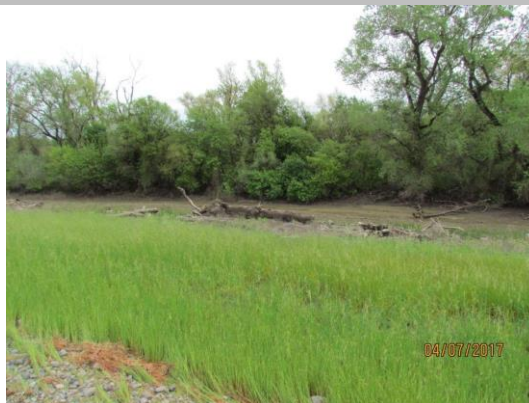
Photo 1 of 1 : SP_2018_ST0009_286_24_20180305_00005.jpg

LM Start	4.35	Rating **	M	Issue No.	24
LM End	4.35	Issue Type +	En	Location *	WS
Category	Earthen Levee			GPS Latitude/Longitude	
				Start	End
Item	Encroachments			39.030637 °	39.030637 °
				-121.743023 °	-121.743023 °
DWR ID	DWR_ST0009_01_s_2017_24				
Comment Code					
DE : Debris					
Inspector Comment					
Remove the debris from the waterside slope and toe.

View of the debris along the waterside slope and toe.

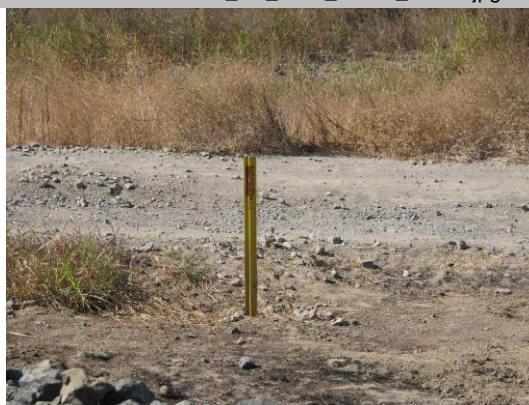
Photo 1 of 3 : UCIP_SP_2018_51487_64235.jpg

Comment Code					
Inspector Comment					
FS_ID:51487 DS_ID:16855 EP_NO: 14455 Repair Type: Non-Urgent Crossing Status: Indicator Found UCIP Comments: 4/10/2017 LS marker still broken and there is no marker on the WS. (DWR Sutter Yard- AFreitag)10/11/2016 LS carsonite marker is still broken.(DWR Sutter Yard - afreitag)4/18/2016 Carsonite marker on LS slope is broke off.5/7/2015 Crossing is in good condition. No noticeable issues to report.11/13/2014 Same as last inspection.5/12/2014 Same as last inspection.10/30/2013 Same as last inspection.5/20/2013 Same as last inspection. FIELD_STRUCT_DESC: 1 of 2: 4.5-inch steel natural gas pipeline through the levee, 2 feet below the crown. Line goes across the Sutter Bypass and through both levees. Carsonite sign on the landside (LS) slope. Drawings are available. (Permit No. 14455, 1986 - Depco Inc.). [Additional Reference(s): DWR Levee Log, 1993]. FS Date: 4/12/2017 9:22:54 AM

Carsonite sign on LS slope.

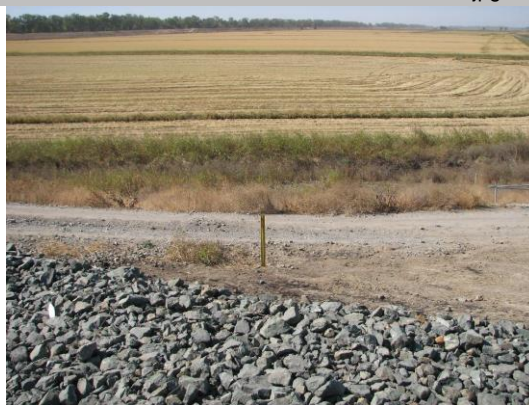
Photo 2 of 3 : UCIP_SP_2018_51488_64232.jpg

Carsonite sign on LS slope.

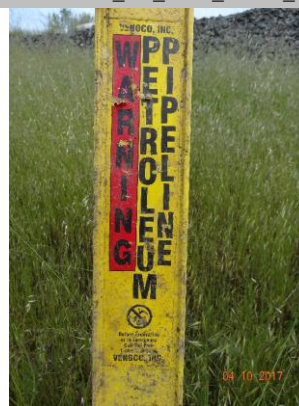
Photo 3 of 3 : UCIP_SP_2018_51488_76943.jpg

Close up of LS marker

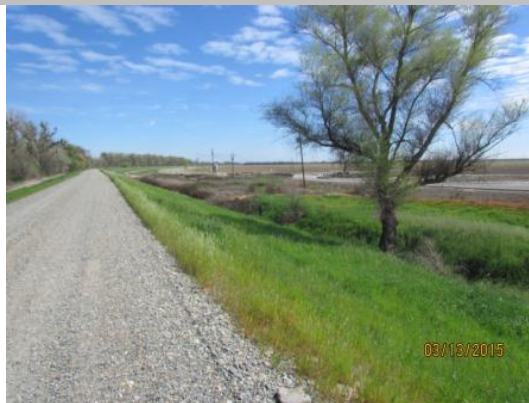
Photo 1 of 1 : SP_2018_ST0009_287_1_20180305_00001.jpg

View of the agricultural ditch along the landside toe.

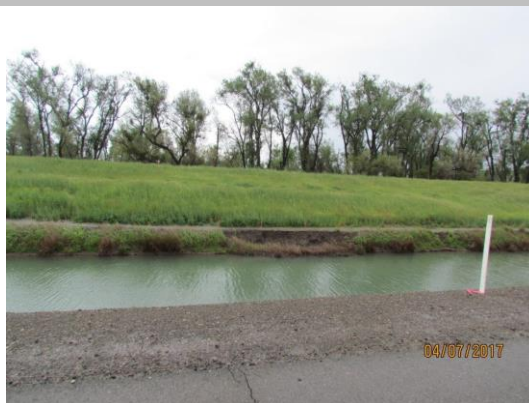
Photo 1 of 1 : SP_2018_ST0009_287_9_20180305_00005.jpg

LM Start	0.69	Rating **	M	Issue No.	9
LM End	0.71	Issue Type +	Ma	Location *	LS
Category	Earthen Levee			GPS Latitude/Longitude	
				Start	End
Item	Erosion / Bank Caving			39.025602 °	39.025657 °
				-121.808527 °	-121.808027 °
DWR ID	DWR_ST0009_02_s_2017_9				
Comment Code					
E2 : Schedule repair of erosion site prior to the next inspection.					
Inspector Comment					
Repair the erosion along the landside toe.

View of the erosion along the landside toe from the County Road.

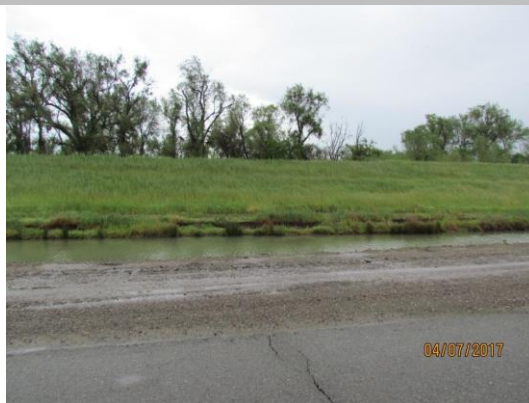
Photo 1 of 1 : SP_2018_ST0009_287_10_20180305_00006.jpg

LM Start	0.97	Rating **	M	Issue No.	10
LM End	0.98	Issue Type +	Ma	Location *	LS
Category	Earthen Levee			GPS Latitude/Longitude	
				Start	End
Item	Erosion / Bank Caving			39.025540 °	39.025572 °
				-121.803272 °	-121.802990 °
DWR ID	DWR_ST0009_02_s_2017_10				
Comment Code					
E2 : Schedule repair of erosion site prior to the next inspection.					
Inspector Comment					
Repair the erosion along the landside toe.

View of the erosion along the landside toe from the County Road.

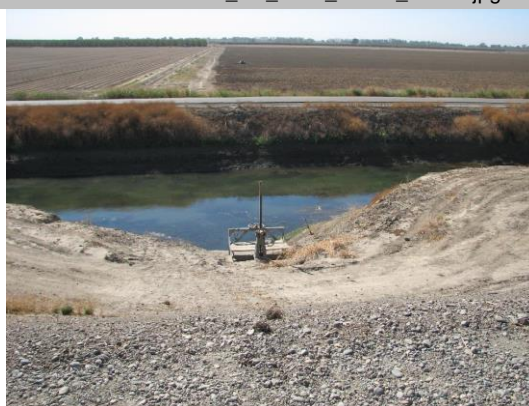
Photo 2 of 3 : UCIP_SP_2018_51489_64674.jpg

Slide gate at concrete outlet on LS toe.

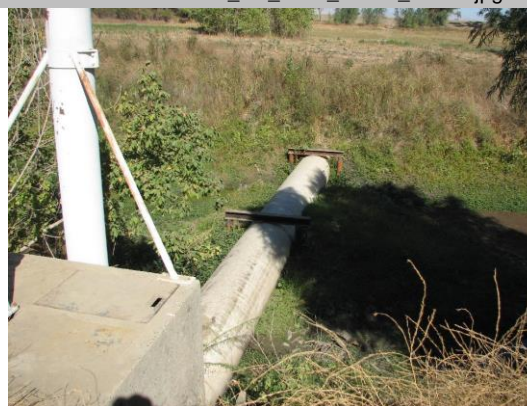
Photo 3 of 3 : UCIP_SP_2018_51489_64673.jpg

Concrete box, vent, and 54-inch steel pipe in WS toe.

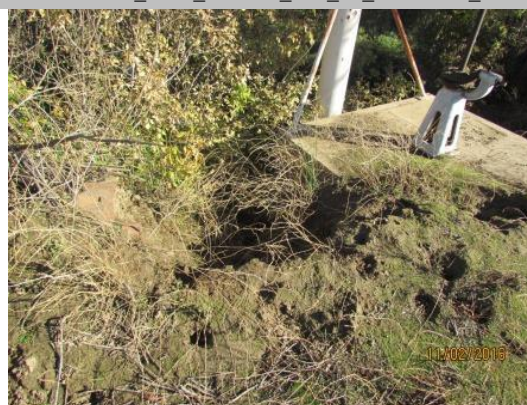
Photo 1 of 2 : SP_2018_ST0009_287_13_20180305_00007.jpg

LM Start	1.14	Rating **	M	Issue No.	13
LM End	1.14	Issue Type +	Ma	Location *	WS
Category	Earthen Levee			GPS Latitude/Longitude	
				Start	End
Item	Erosion / Bank Caving			39.025460 °	39.025460 °
				-121.800022 °	-121.800022 °
DWR ID	DWR_ST0009_02_f_2016_13				
Comment Code					
E2 : Schedule repair of erosion site prior to the next inspection.					
Inspector Comment					
Erosion around the WS concrete vault.

View of the erosion along the concrete vault.

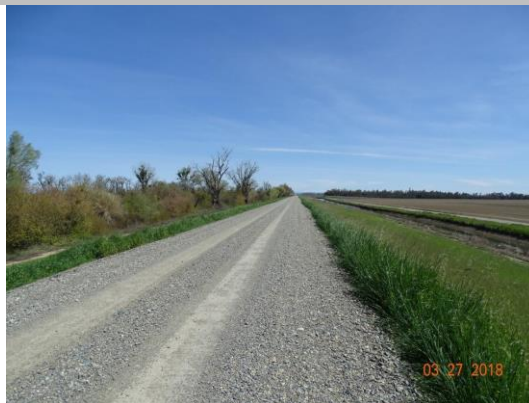
Photo 1 of 1 : SP_2018_ST0009_287_7_20180403_00017.jpg

View of native grasses on both slopes.

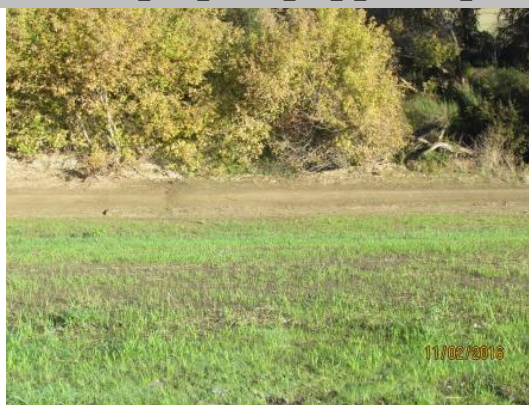
Photo 1 of 1 : SP_2018_ST0009_287_5_20180305_00004.jpg

LM Start	1.48	Rating **	A/W	Issue No.	5
LM End	1.50	Issue Type +	Ma	Location *	WS
Category	Earthen Levee			GPS Latitude/Longitude	
				Start	End
Item	Erosion / Bank Caving			39.025460 °	39.025446 °
				-121.793815 °	-121.793347 °
DWR ID	DWR_ST0009_02_s_2013_5				
Comment Code					
E2 : Schedule repair of erosion site prior to the next inspection.					
Inspector Comment					
Sutter Yard needs to monitor the erosion.

View of the erosion along the waterside berm.

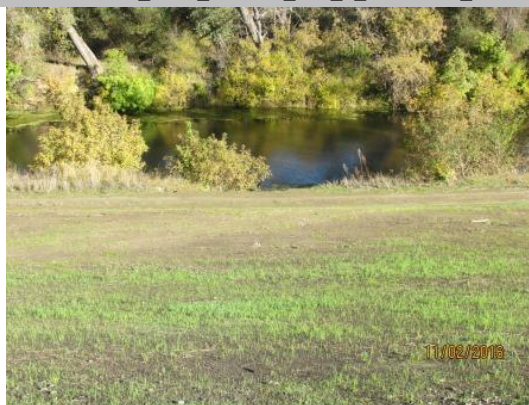
Photo 1 of 1 : SP_2018_ST0009_287_2_20180305_00002.jpg

LM Start	3.93	Rating **	A/W	Issue No.	2
LM End	3.93	Issue Type +	Ma	Location *	WS
Category	Earthen Levee			GPS Latitude/Longitude	
				Start	End
Item	Erosion / Bank Caving			39.025060 °	39.025060 °
				-121.748178 °	-121.748178 °
DWR ID	DWR_ST0009_02_f_2016_2				
Comment Code					
E1 : Note and monitor erosion site.					
Inspector Comment

View of the erosion along the waterside berm.

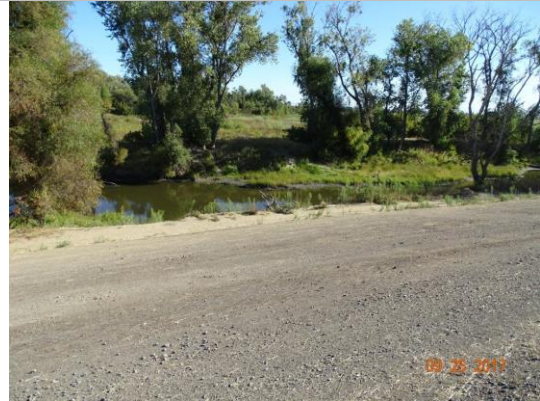
Photo 1 of 1 : SP_2018_ST0009_287_18_20180305_00009.jpg

LM Start	4.09	Rating **	A/W	Issue No.	18
LM End	4.09	Issue Type +	Ma	Location *	WS
Category	Earthen Levee			GPS Latitude/Longitude	
				Start	End
Item	Erosion / Bank Caving			39.024912 °	39.024912 °
				-121.745237 °	-121.745237 °
DWR ID	DWR_ST0009_02_f_2017_18				
Comment Code					
E2 : Schedule repair of erosion site prior to the next inspection.					
Inspector Comment					
Repair the erosion along the water side berm.

View of the erosion along the waterside berm.

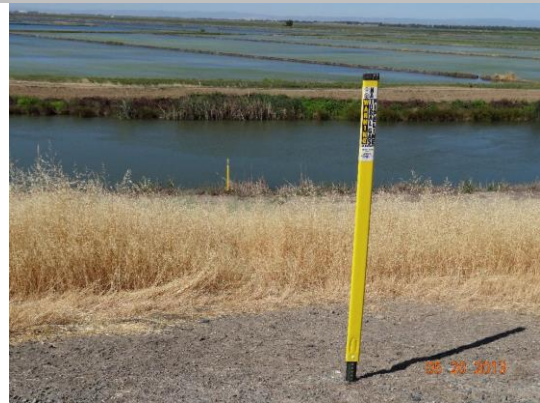
Photo 1 of 3 : UCIP_SP_2018_51491_64681.jpg

Comment Code					
Inspector Comment					
FS_ID:51491 DS_ID:23099 EP_NO: N/A Repair Type: Non-Urgent Crossing Status: Found UCIP Comments: 4/10/2017 Crossing appears to be in good condition. (DWR Sutter Yard- AFreitag)10/11/2016 Crossing appears to be in good condition but there is no permit on file. Photos of the markers were uploaded on 5/20/2013.(DWR Sutter Yard - afreitag)5/3/2016 Need photos of markers on both WS and LS. 4/18/2016 Crossing appears to be in good condition. No noticeable issues to report.5/7/2015 Crossing is in good condition. No noticeable issues to report.11/13/2014 Same as last inspection.5/12/2014 Same as last inspection.10/30/2013 Same as last inspection.10/17/2012 Need to identify permit for crossing. FIELD_STRUCT_DESC: Steel natural gas pipeline of an unknown size through the levee, at an unknown depth. Markers visible on the landside (LS) shoulder and toe and the waterside (WS) shoulder and toe. No permit has been identified since the crossing was field discovered in 2012. FS Date: 4/12/2017 9:30:05 AM

Marker on LS shoulder and toe

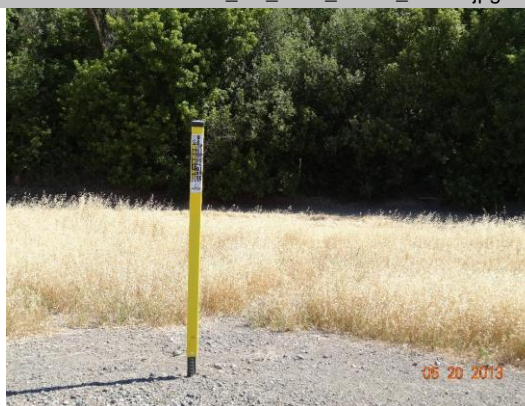
Photo 2 of 3 : UCIP_SP_2018_51491_64680.jpg

Marker on WS shoulder

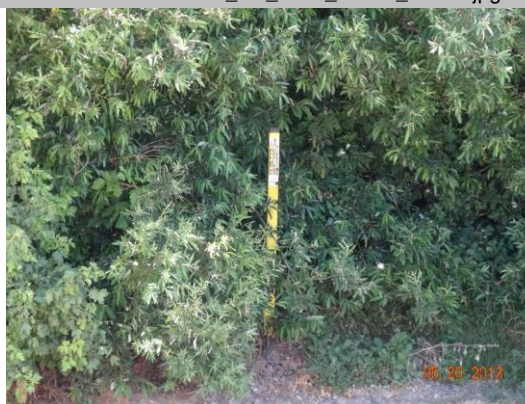
Photo 3 of 3 : UCIP_SP_2018_51491_64679.jpg

Marker on WS toe
